**B737-800, EI-CSG SERIOUS INCIDENT
“CABIN DEPRESSURIZATION”
France
08 Jun. 2016**

**FINAL REPORT OF SERIOUS INCIDENT
INVESTIGATION
17.Aug.2018**

B737-800, EI-CSG CABIN DEPRESSURIZATION

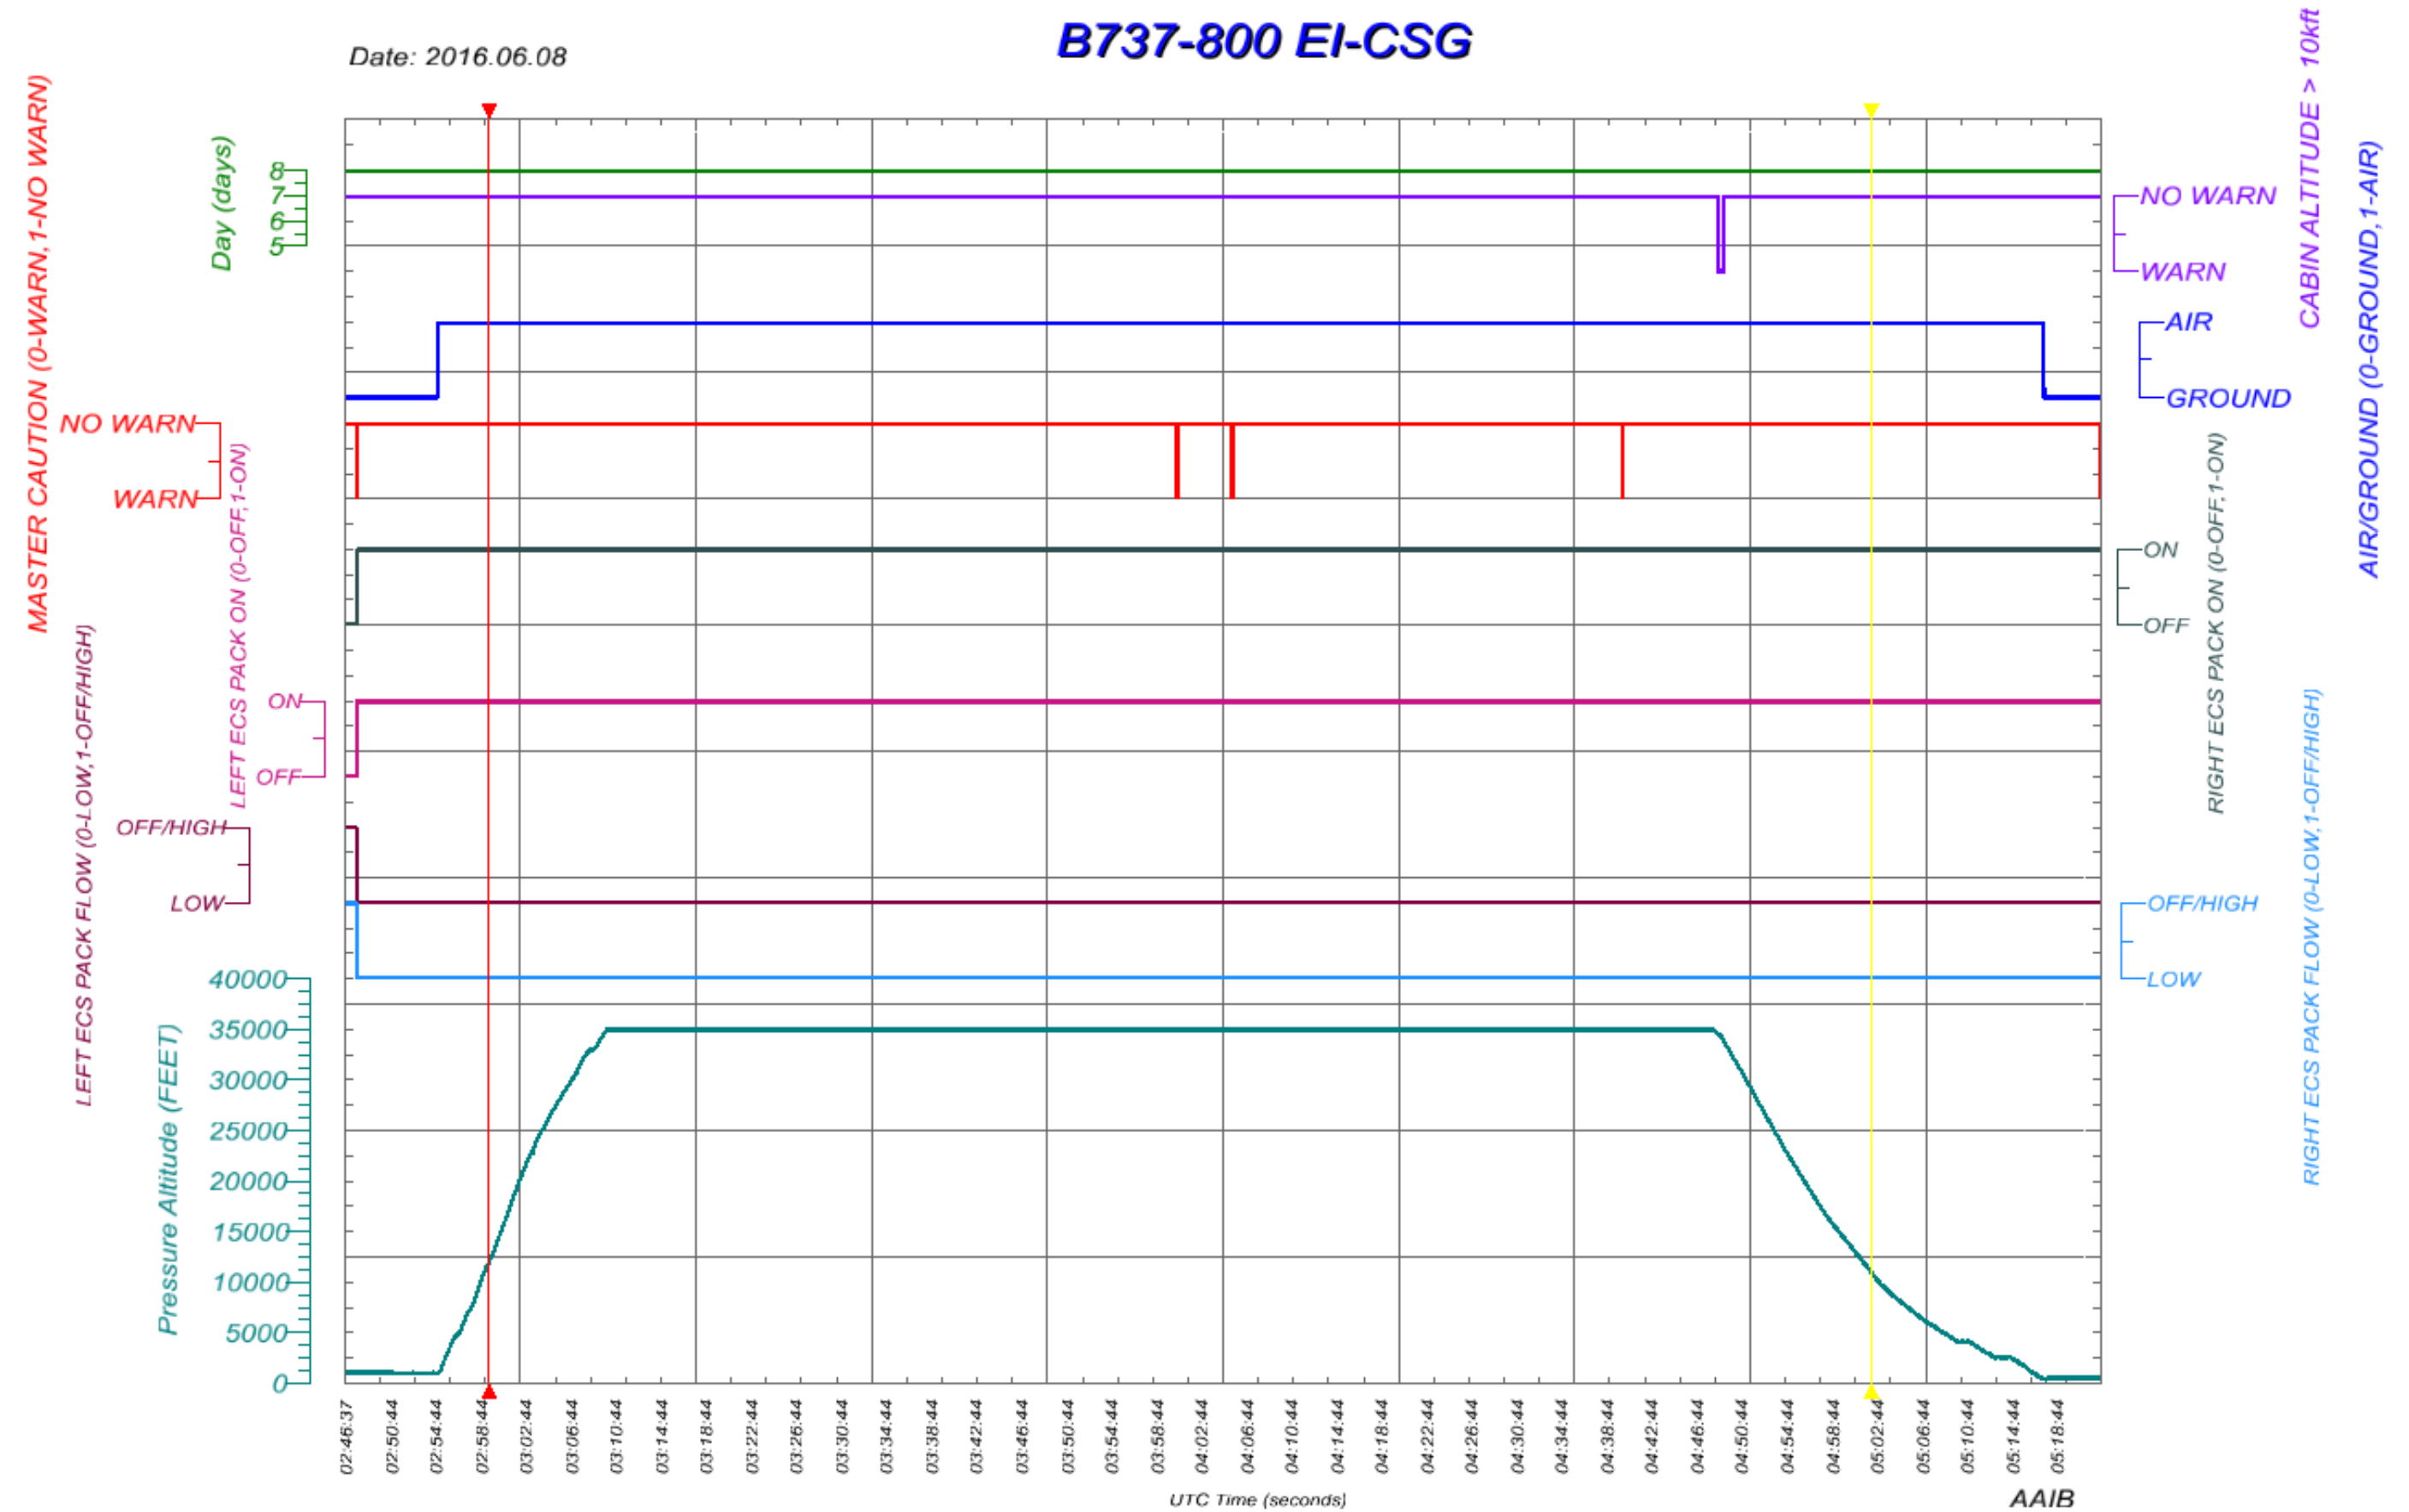
Figure 3. First flight of 2016.06.08 (PRG-KGS)

On 08 Jun, EI-CSG aircraft was operated in 4 flights. On the PRG-KGS flight, the “Auto Fail” light illuminated and crew selected to the MAN mode. The aircraft has been landed at KGS at UTC 05:25 and #2 controller showed fault code FC014 when onboard engineer performed a check according to instructions specified in FIM Task 21-31, Task 801. The aircraft started the next flight at UTC 06:40 after the check.

08 Jun 2016, when both auto channel of cabin pressurisation system became inoperative (Auto Fail failure) during PRG-KGS flight, flight crew has manually controlled the outflow valve. But the crew did not report that cabin altitude has increased over 10,000 feet and cabin altitude warning was activated.

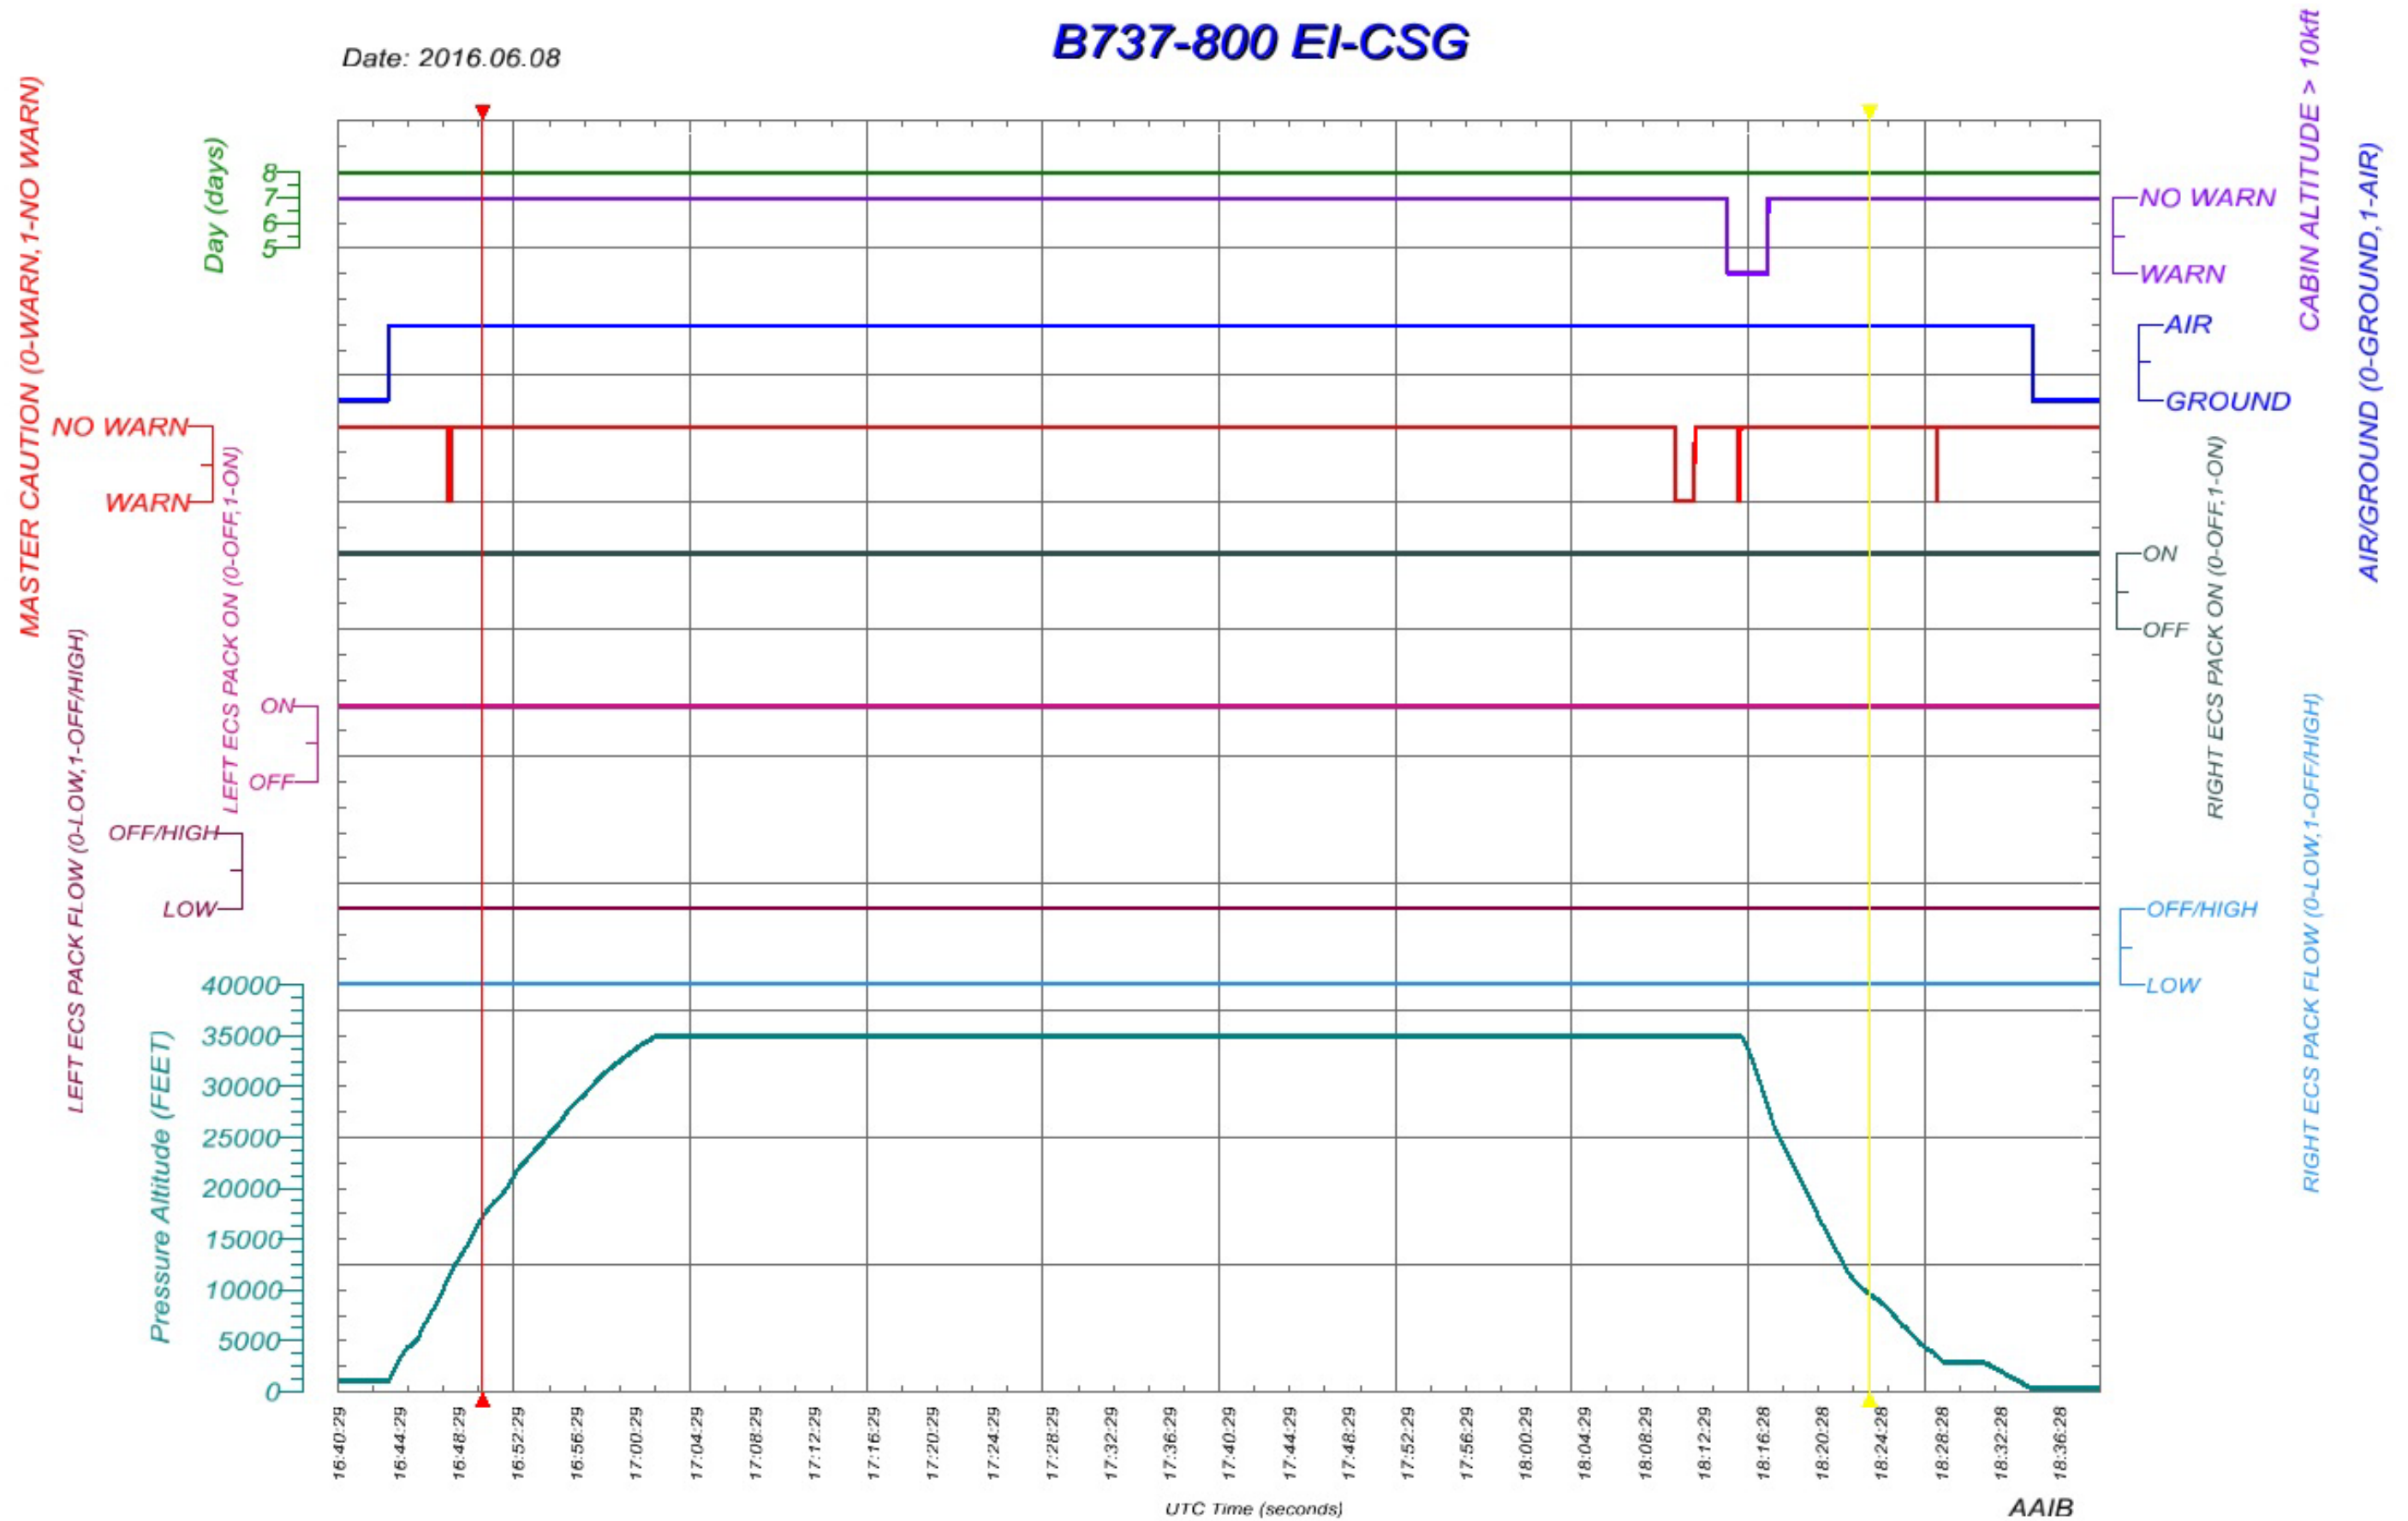
Figure 4. Flight PRG-SVQ (TLS) dated 2016.06.08

- With the occurrence of "14 auto under test" fault or when Autofail light illuminated, the two controller motors are locked and thereafter outflow valve position 9.7 degrees can only be changed by manual control,
 - After "Auto Fail" light illumination, flight crew selected MAN mode.
 - When the "17 Not used" or cabin altitude exceeded 10,000 feet, the system was in MAN mode, the outflow valve position was 39 degrees, the flight altitude has not been changed and the cabin altitude has increased with rate 7836.5 slfpm.

This shows that the outflow valve position has been changed from 9.7 degrees to 39 degrees in MAN mode and it might be the cause of sudden drop of cabin pressure.

During the cruise flight at 35,000 feet over the territory of France (Lat 44632188N, Long 1.793517E, 83 km away from TLS airport) "Auto fail" and Master caution lights illuminated again. At this time the cabin pressure system was in ALTN mode and the outflow valve position was at 9.7 degree.

Safety recommendation 2017-02-09. To MIAT. Replace controllers of the cabin pressurisation system by controllers with higher reliability in accordance with manufacturer recommendation and manuals.

Safety recommendation 201702/10. To MIAT. Perform task for download and check of the controllers' memory of cabin pressurisation system with regular interval.
